SHREWSBURY STEAM TRUST

NEWSLETTER FEBRUARY 2016

“Up where the smoke is all billow’d and curled.....”

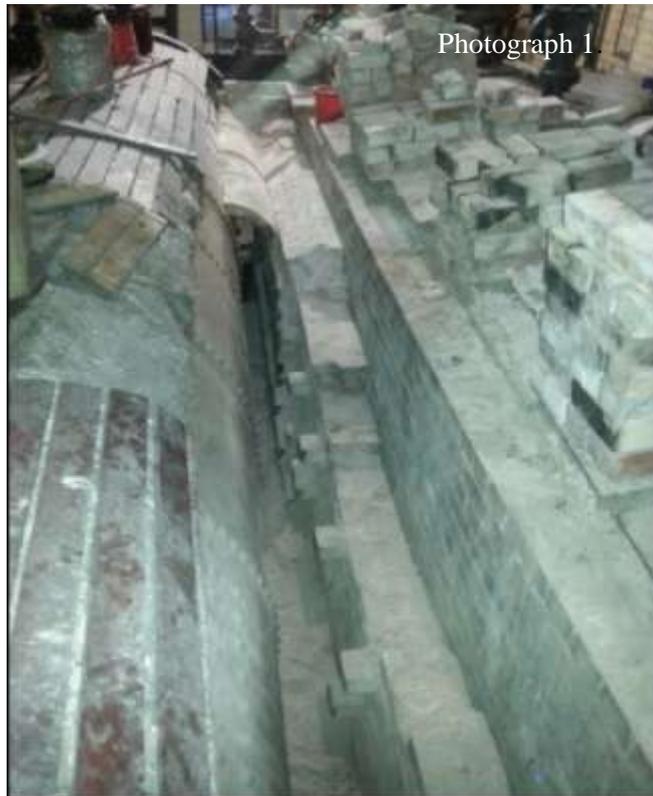
the passageway alongside the boiler. This exposed the top of the dividing wall and the curved firebrick ‘roof’ of the flue. These can be seen Photograph 1. These curved firebricks are not mortared into place. Their base is resting on the top of the flue lining bricks, and their top edge simply leans against the side of the boiler. Also visible in the photo is the partly-removed dividing wall: the red plastic bucket (not the one on top of the boiler) is sitting on the top of the intact wall for the other boiler. These two walls are separated by a small gap of one to two inches, and they do not seem to be tied together at all. They are made of hard red bricks and good-quality mortar, and apart from the area which has been removed in photo 1, seem to be sound. The walls are double width, with headers protruding into the flue passage: these support the lining bricks and can be seen in photo 1 where the lining has been removed. (See below for more about the bricks).

The flue lining is in poor condition. The bricks are again hard, and are of a more yellow colour than the walls, but generally sound. It is the mortar which has failed, and is little more than sand. The bricks were recovered by simply picking them out by hand and dusting the mortar off. It is possible that the effects of the heat and chemical action of the smoke and gasses has caused the mortar to perish, but it may be that a poor quality mortar mix was used in construction. The new mortar will be specifically chosen to reduce the effects of smoke in future.

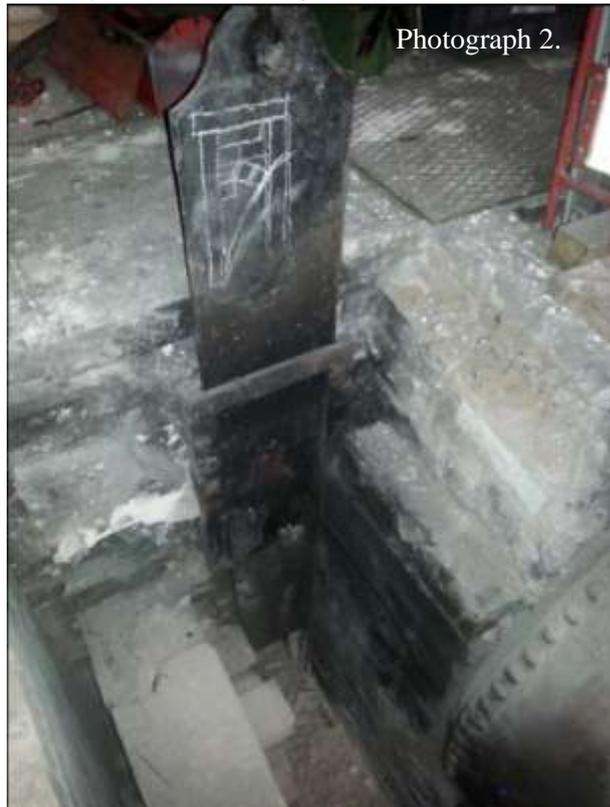
Photograph 2.

Photograph 2 shows one of the dampers in a partly-raised position. Again, the headers used to support the lining bricks can be seen. There is some evidence of previous repairs in the area around the damper. The brickwork here is generally sound and the mortar is good. In particular, the brickwork between the end of the boiler and the damper has clearly been re-made at some time.

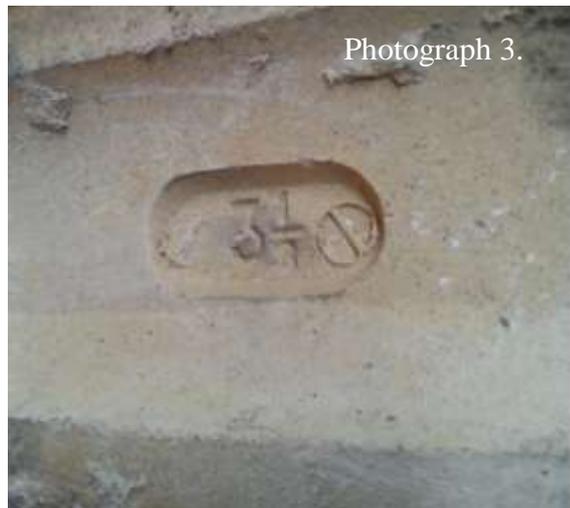
Photograph 3.

Photograph 3 shows such a brick, stamped "3/8" on one side, and "J.C.E." on the other.

Research suggests that these bricks are supplied by James Coater Edwards from Ruabon, north Wales. He followed his father into the brick-making business and at one stage had three factories. Buff coloured bricks generally came from The Albert Works at Rhosllannerchrugog. Edwards bricks were also used in the construction of the Panama Canal (opened 1914), and for some of the supporting structures of Blackpool Tower (opened 1894) and Ibrox Stadium in Glasgow.

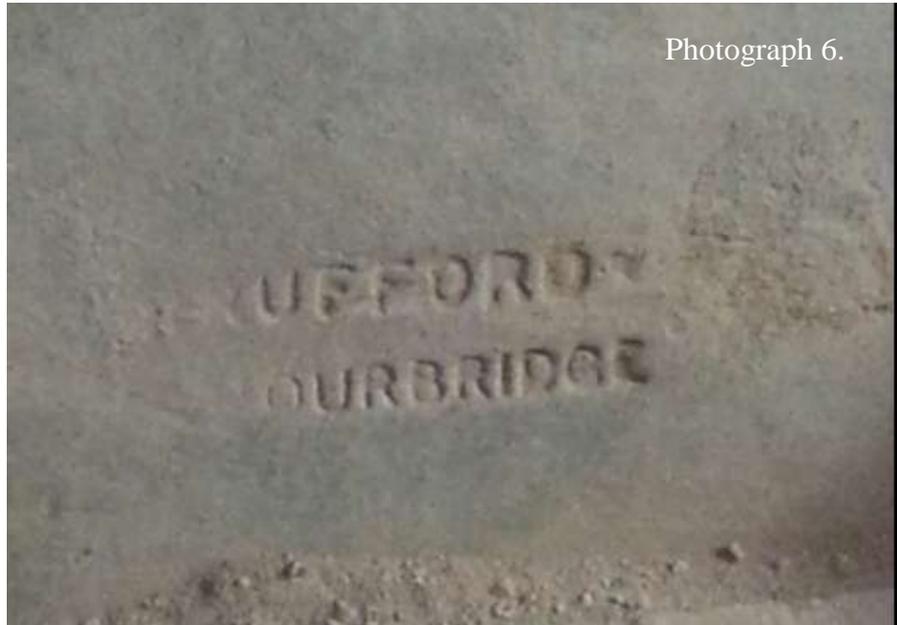
Photograph 6.

The curved firebricks used to form the 'roof' on the flue are also Ruffords products.

See Photograph 6

Ruffords were based in Hungary Hill, Stourbridge, and were famous for the manufacture of firebricks and glazed utility ware. They had a reputation for superb quality and their fire-clay products were known to withstand high temperatures.
